Cedar Fold

Demolition of Former Residential Property

Successful Remediation - On Time, On Budget

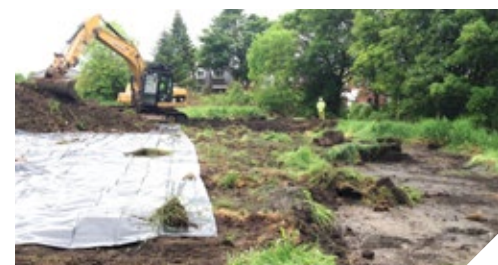
Himalyan Balsam Excavation

Invasive species management comprised the excavation (200 mm deep) of all balsam impacted soils for stockpiling prior to on-site burial at depth (3 m bgl). All Japanese Knotweed affected soils were excavated under supervision with materials removed off-site to licenced tip.

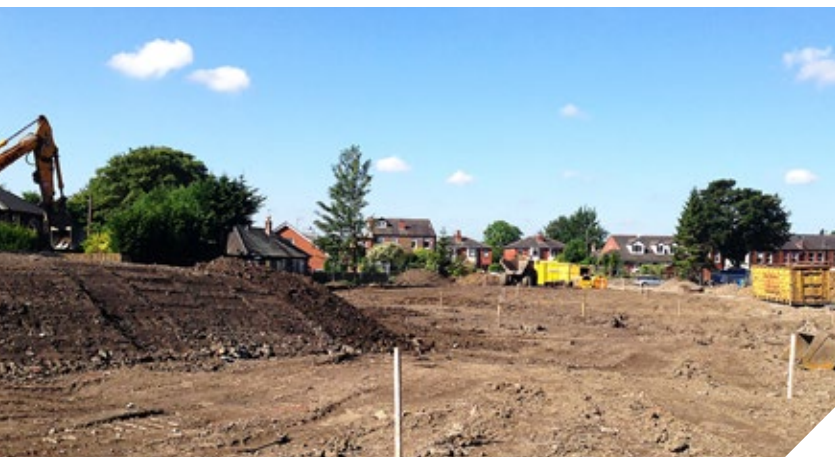
Sub-Soil Management

Further to completing a demolition and refurbishment survey the existing site residential buildings were demolished and all masonry and hardstand recovered and crushed as 6F2 for re-use. Excavation and processing of madeground was undertaken under Environmental Engineer supervision with screening and picking of deleterious, over-size and suspected ACM.

The site was re-engineered to construction formation levels and designed to provide validated sub-soils for all gardens of the 30No. unit development.
